Important Product Information

PACSystems* RX3i

IC695CPU315-CP

PACSystems* RX3i CPU

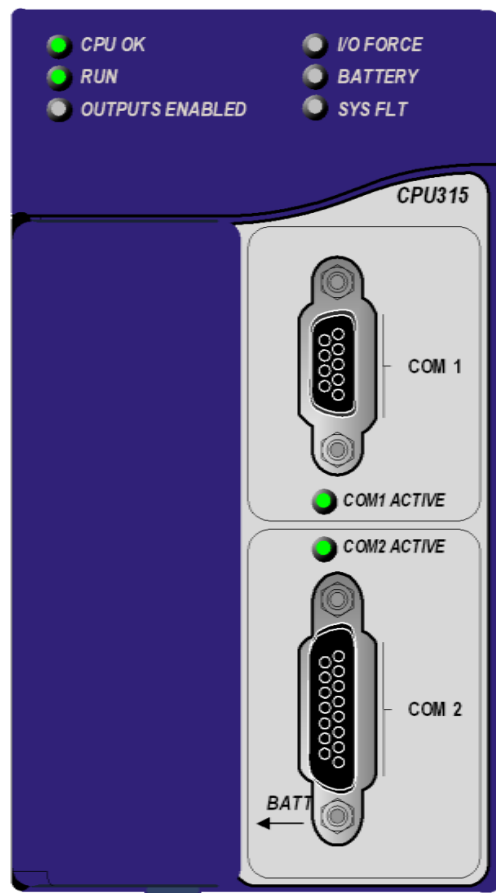
The PACSystems* RX3i CPU can be used to perform real time control of machines, processes, and material handling systems. The CPU communicates with the programmer and HMI devices via a serial port using SNP Slave protocol. It communicates with I/O and smart option modules over a dual backplane bus that provides:
