PACSystems™ RX3i

SERIAL COMMUNICATION MODULES (IC695CMM002 & IC695CMM004)

Product Description

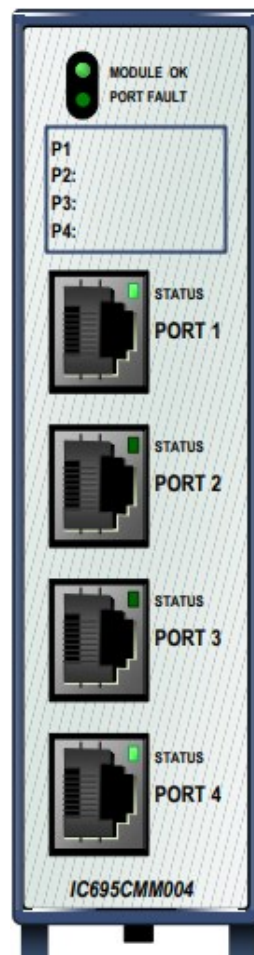
Serial Communications module IC695CMM002 provides two independent, isolated serial ports. Serial Communications module IC695CMM004, illustrated at right, provides four independent, isolated serial ports.
